**ARCHAEOLOGICAL ADVICE – PROPOSED KAIAIO
IRRIGATION AND WATER SUPPLY SCHEME, TE KAHA,
STATE HIGHWAY 35, ŌPŌTIKI DISTRICT**

This letter of advice records the results of desk-based research and an archaeological field inspection for the purpose of assessing the potential impact of ground disturbance associated with the proposed irrigation and water supply scheme on the archaeological landscape around Te Kaha; and provides advice regarding site conservation and legal compliance.

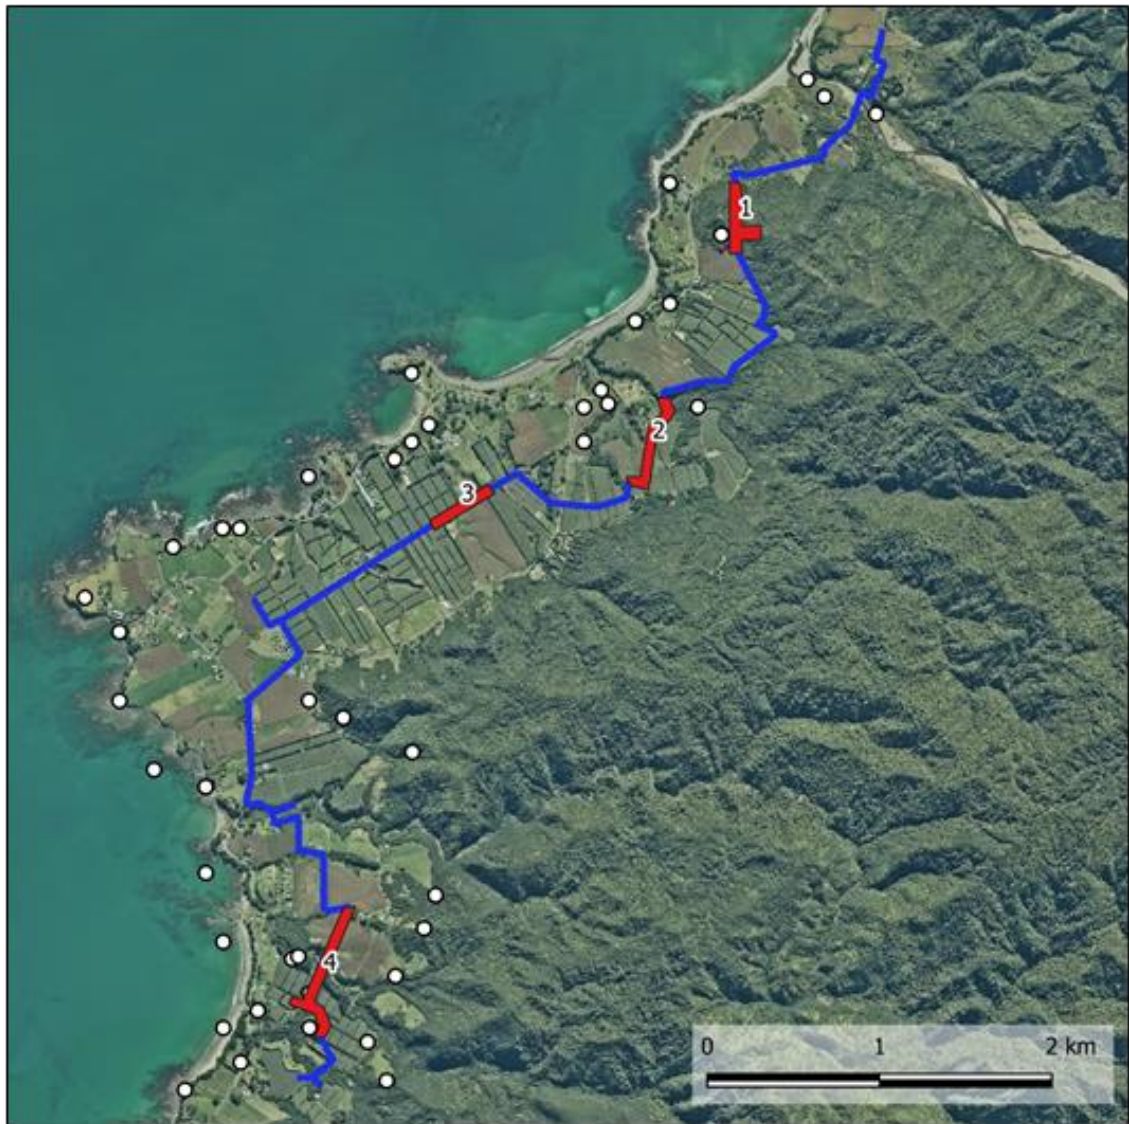
There are several recorded archaeological sites within a 10m corridor either side of the proposed pipeline route. Drawing upon the location of these sites combined with previous archaeological research within the eastern Bay of Plenty and the nature of proposed activity in different zones based on the Construction Management plan provided by Todd Land Development Ltd; the desktop review categorised the pipeline route into areas of high and low risk for encountering archaeological sites (Figure 1). High-risk zones were recommended for follow up survey.

Figure 1- Proposed water pipeline with areas identified by desktop research as low risk shown in blue and high risk shown in red. Recorded archaeological sites are shown as white circles.

The initial high-risk designation for certain areas of the pipeline (Figure 1, red areas) has subsequently been revised to low-risk, making the whole project low-risk in terms of the potential to impact on archaeological features.

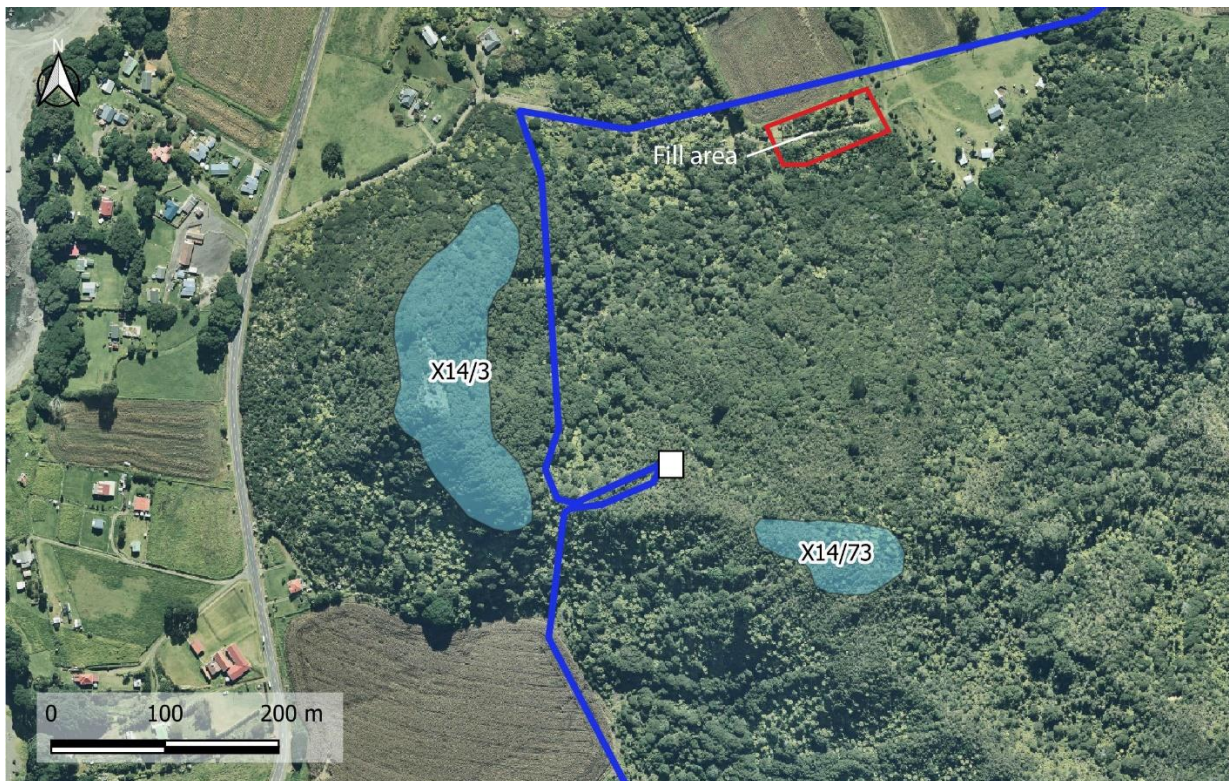
Area 1 – this section of pipe runs over the saddle to the east of Maungaroa pā (X14/3). A reservoir site is planned on the hill, east of the main pipeline (white square, Figure 2). The proposed pipeline route, the saddle, the ridgeline to the east and Maungaroa pā were inspected. A new pit/terrace site was recorded along the ridge to the east of the pipeline (X14/73), the western extent of this site is approximately 100m away from the reservoir site. Maungaroa pā was found to be far more extensive than originally

recorded, with features extending down the southern extent of the hill into the saddle (Figure 2). The pipeline will utilize a track cut to this area for the installation of powerlines, which passes 30m west of the extent of Maungaroa pā. Use of this track will ensure that there should be no impact on archaeological features in this area provided extensive cutting back of the existing batter is not carried out.

A fill area is planned for excess material from the reservoir site. No archaeological features/deposits will be impacted by this activity.

Figure 2 – The proposed pipeline route and location of the reservoir site in relation to Maungaroa pā (X14/3) and the newly recorded pit/terrace site X14/73. The proposed fill area associated with the reservoir site is shown at the top of the image.
