# Waiotaha Drifts Subdivision, Stage 5a

## Geotechnical Completion Report

Prepared for Maven Associates Ltd.

Project 48749 - 25/05/2022

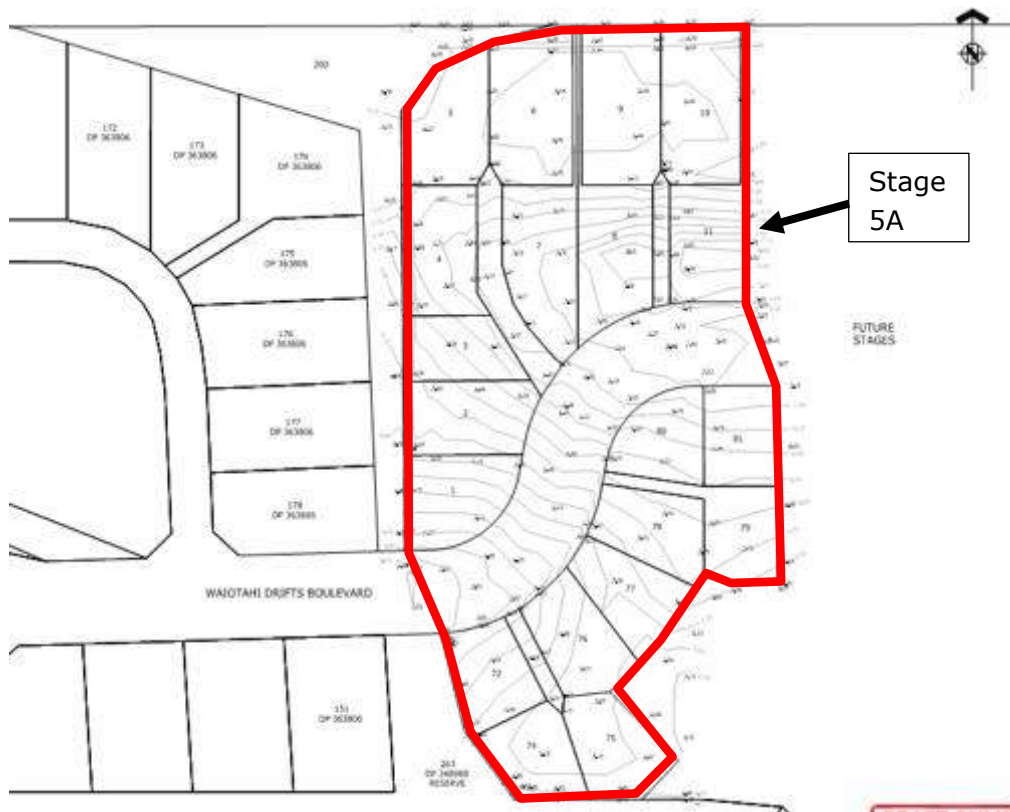
**Figure 1: Subdivision plan for Stage 5A**

The proposed development plans, provided by Maven Associates forms Appendix A.

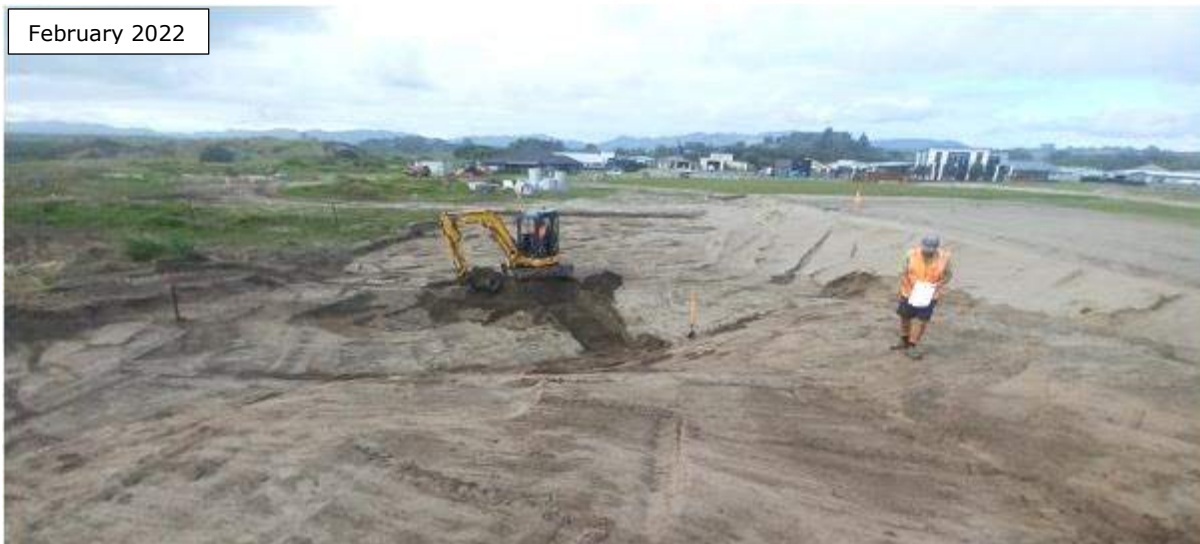
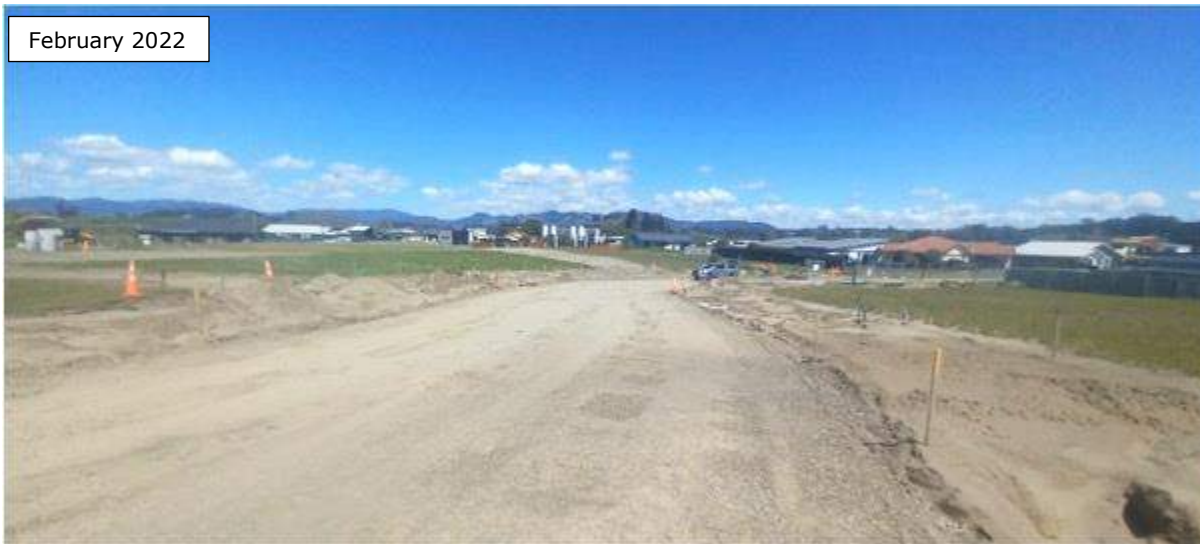
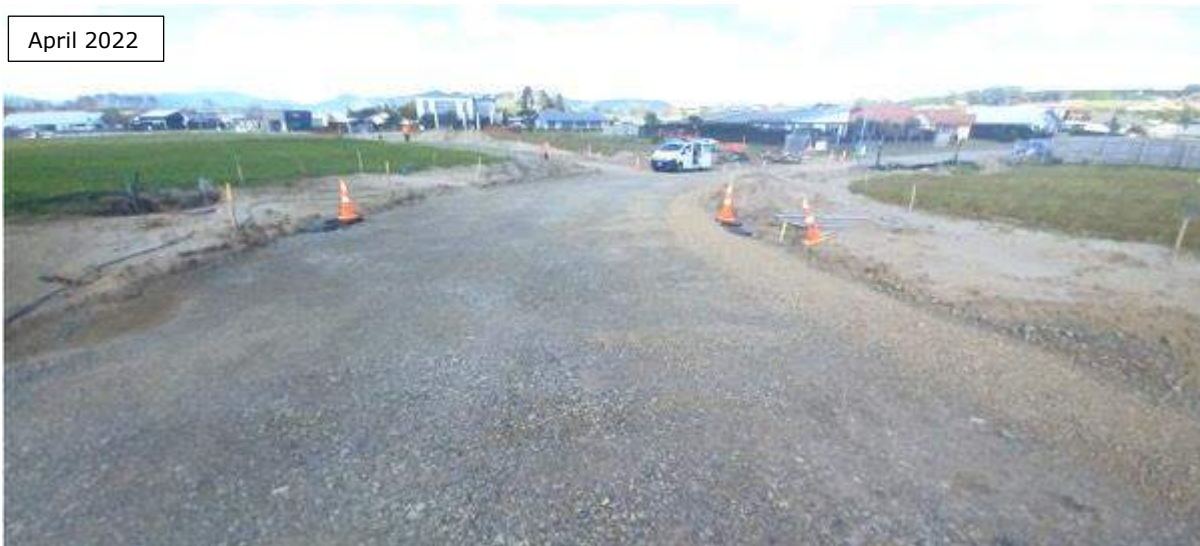
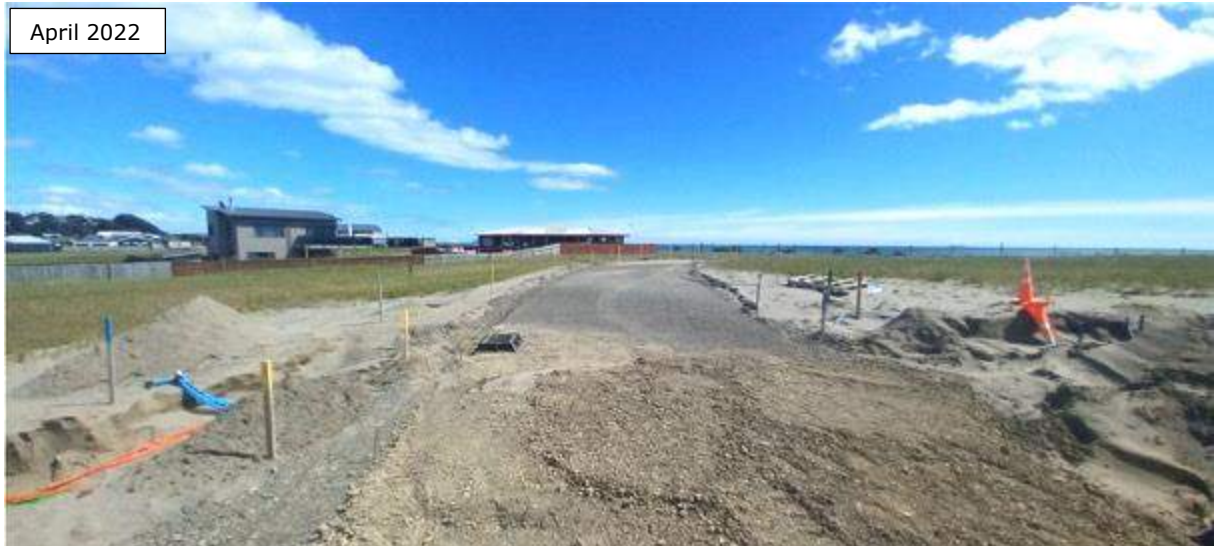
**Figure 5: Images from October 2021 – April 2022**

The initial compaction methodology and difficulties attaining sufficient moisture content in the earth fill resulted in insufficient compaction. Additional compaction equipment & sprinkler system installation improved performance and all areas of earth fill (except the fill on the western and south-western boundaries – see below), roading subgrade and base coarse in Stage 5a are considered to meet the Maven Fill Specification. EDC's Site Inspection Notes form Appendix C.

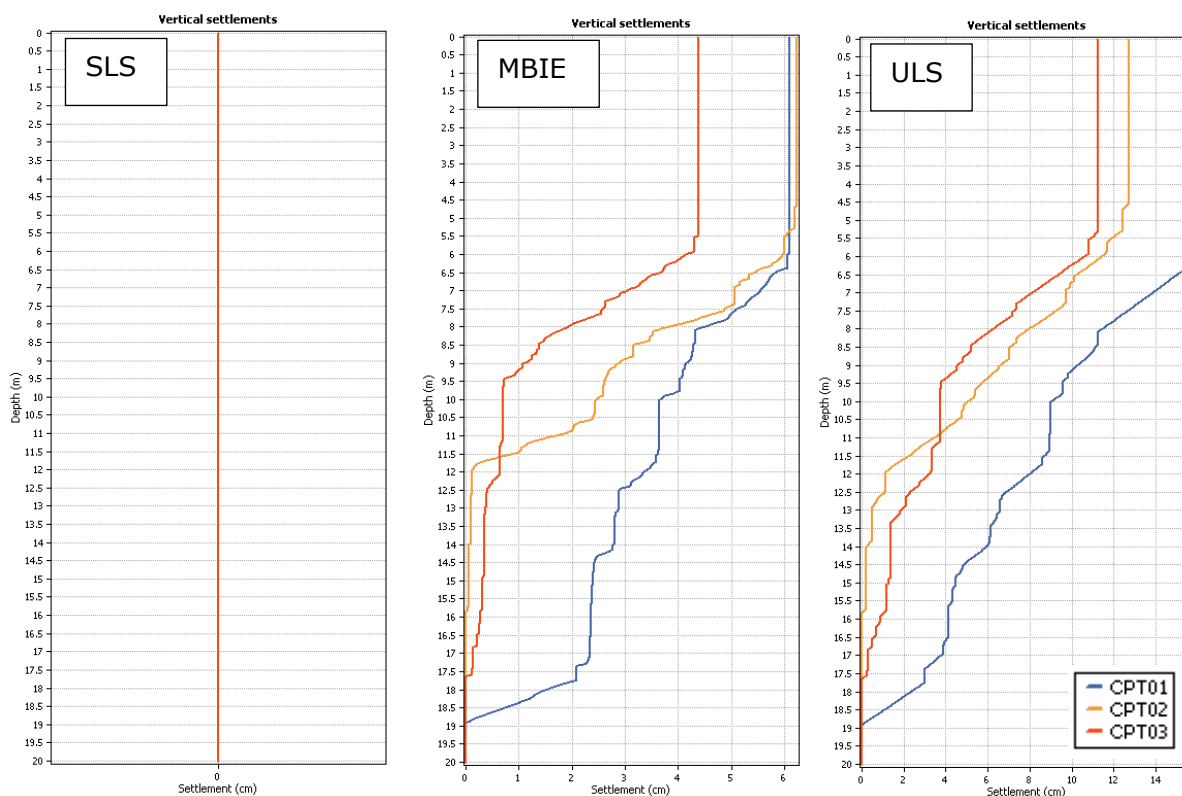
**Figure 7: Estimated Total Vertical Settlement under SLS, MBIE 100yr and ULS Conditions**

The on-site CPT analyses indicate:

Under SLS conditions, negligible settlement is to be expected, under MBIE conditions up to 62mm of settlement is to be expected and up to 157mm of settlement is to be expected under ULS conditions.

Based on this and the MBIE Foundation Technical Category criteria we recommend a TC2 foundation system (Ministry of Business, Innovation and Employment, 2015).
